# **NATIONAL TRANSPORTATION SAFETY BOARD**

## **AIRCRAFT ACCIDENT REPORT**

**MIDAIR COLLISION OF  
NABISCO BRANDS, INC.,  
DASSAULT FALCON, DA50, N784B AND  
AIR PEGASUS CORPORATION  
PIPER ARCHER, PA28-181, N1977H  
FAIRVIEW, NEW JERSEY  
NOVEMBER 10, 1985**

**NTSB/AAR-87/05**

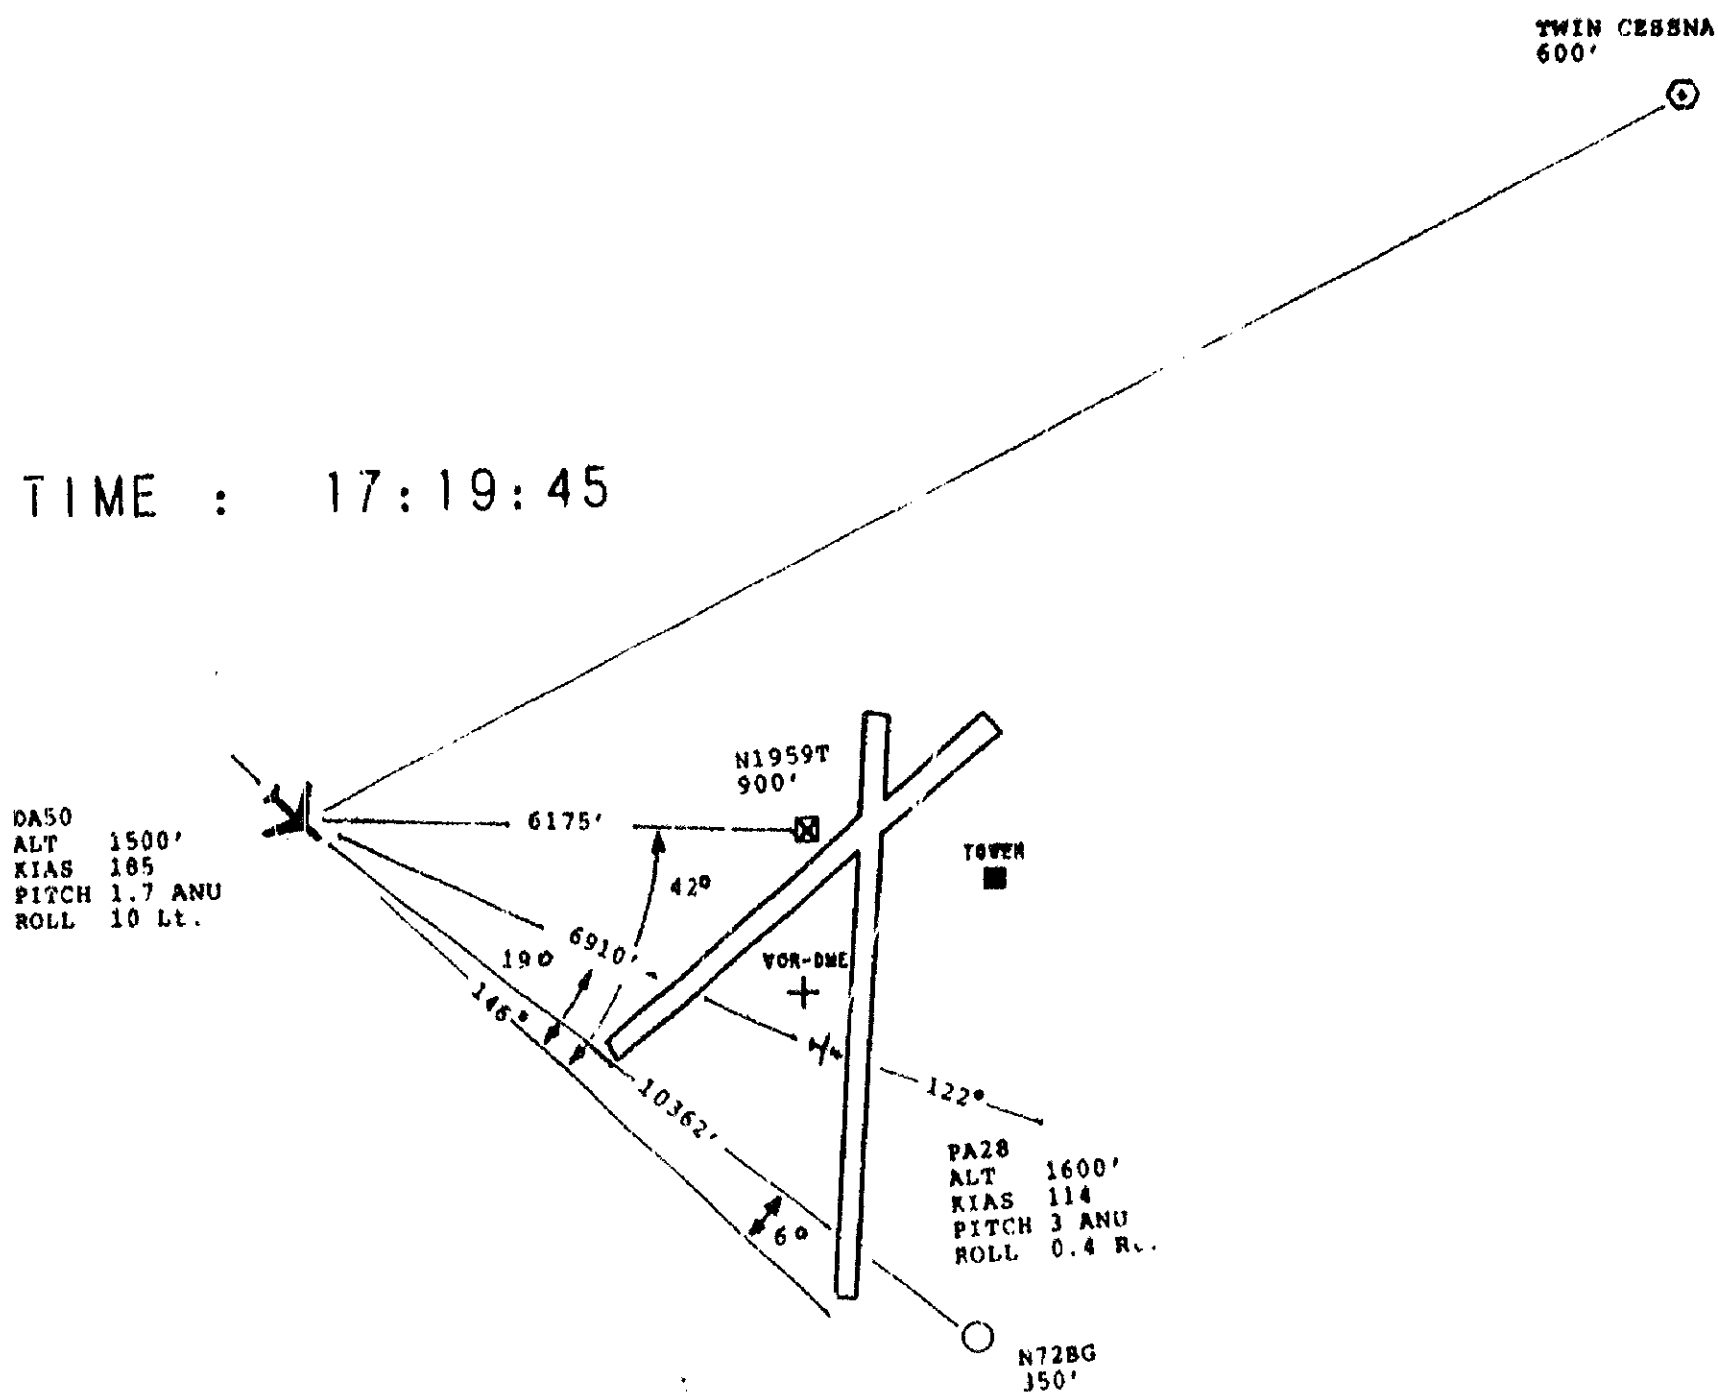
Figure 2.--Radar positions of aircraft at 1719:45.

At 1719:24, the captain transmitted, "...inside WANES. ah, inside CLIFO, airport's in sight." About the same time, N72BG requested, "...left downwind departure." However, the local controller did not immediately acknowledge either airplane's report, but transmitted, "Four six juliet is cleared for takeoff runway one niner." At 1719:38, the controller transmitted, "Bravo golf, remain east of the Hackensack River" and N72BG acknowledged. Immediately, N1959T reported overhead the airport and the local controller stated it was number two following traffic (Twin Cessna N68734) on a left base leg over route 80 but he did not state N1959T's aircraft type. At this same time the DA50 was in a 10° left bank at about 185 knots on a heading of 146° and the captain stated to the first officer, "Better slow it up Alan, we're following that guy." The first officer said, "Okay" and he called for flaps. (See figure 2.)

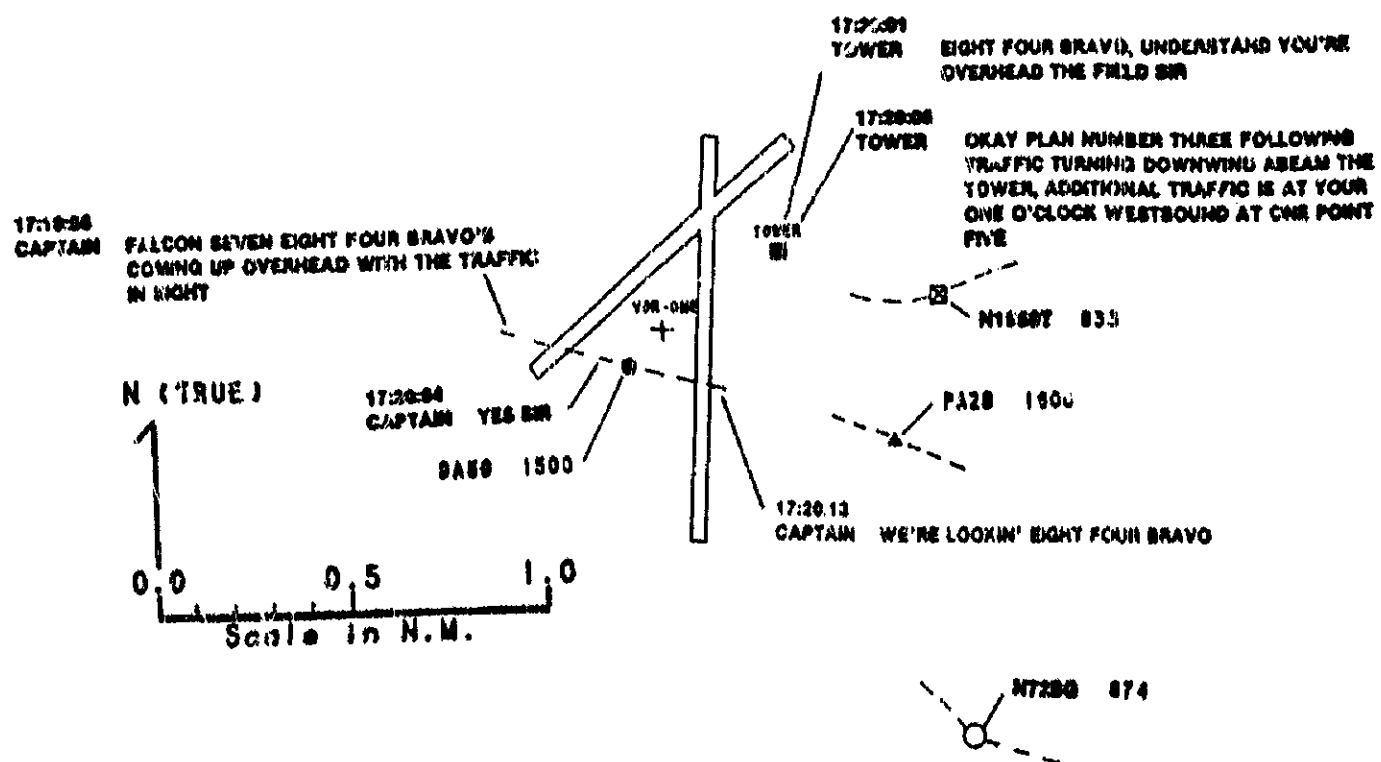
Figure 18.—Composite radar positions and cockpit visibility plot of aircraft at 1720:05.

Based on the radar data and cockpit visibility study at 1719:45, when the DA50 was about a mile west of the airport, the Twin Bonanza, N1959T, and the PA28 were passing over the airport in front of and in the DA50 flightcrew's view. (See figure 17.) N1959T was about 40° to the left at 900 feet and the PA28 was about 20° to the left of the crew's DER at 1,600 feet on the horizon. The Beech Baron, N72BG, which had departed to the east after takeoff from runway 19, was located slightly to the left of the crew's DER, and to the right of the PA28 and slightly below the horizon at 350 feet. At 1720:05, when the local controller told the DA50 flightcrew that they were to plan to be number three and there was additional traffic at the one o'clock position westbound at 1,500 feet, N1959T was about 20° to the left of the crew's DER, the PA28 was directly ahead at the 12 o'clock position, and N72BG was 1.5 miles ahead at 873 feet, 25° to 30° to the right of the DA50 crew's DER or in about a 1 to 2 o'clock position. (See figure 18.)
