# **NATIONAL TRANSPORTATION SAFETY BOARD**

## **AIRCRAFT ACCIDENT REPORT**

**MIDAIR COLLISION OF  
NABISCO BRANDS, INC.,  
DASSAULT FALCON, DA50, N784B AND  
AIR PEGASUS CORPORATION  
PIPER ARCHER, PA28-181, N1977H  
FAIRVIEW, NEW JERSEY  
NOVEMBER 10, 1985**

**NTSB/AAR-87/05**

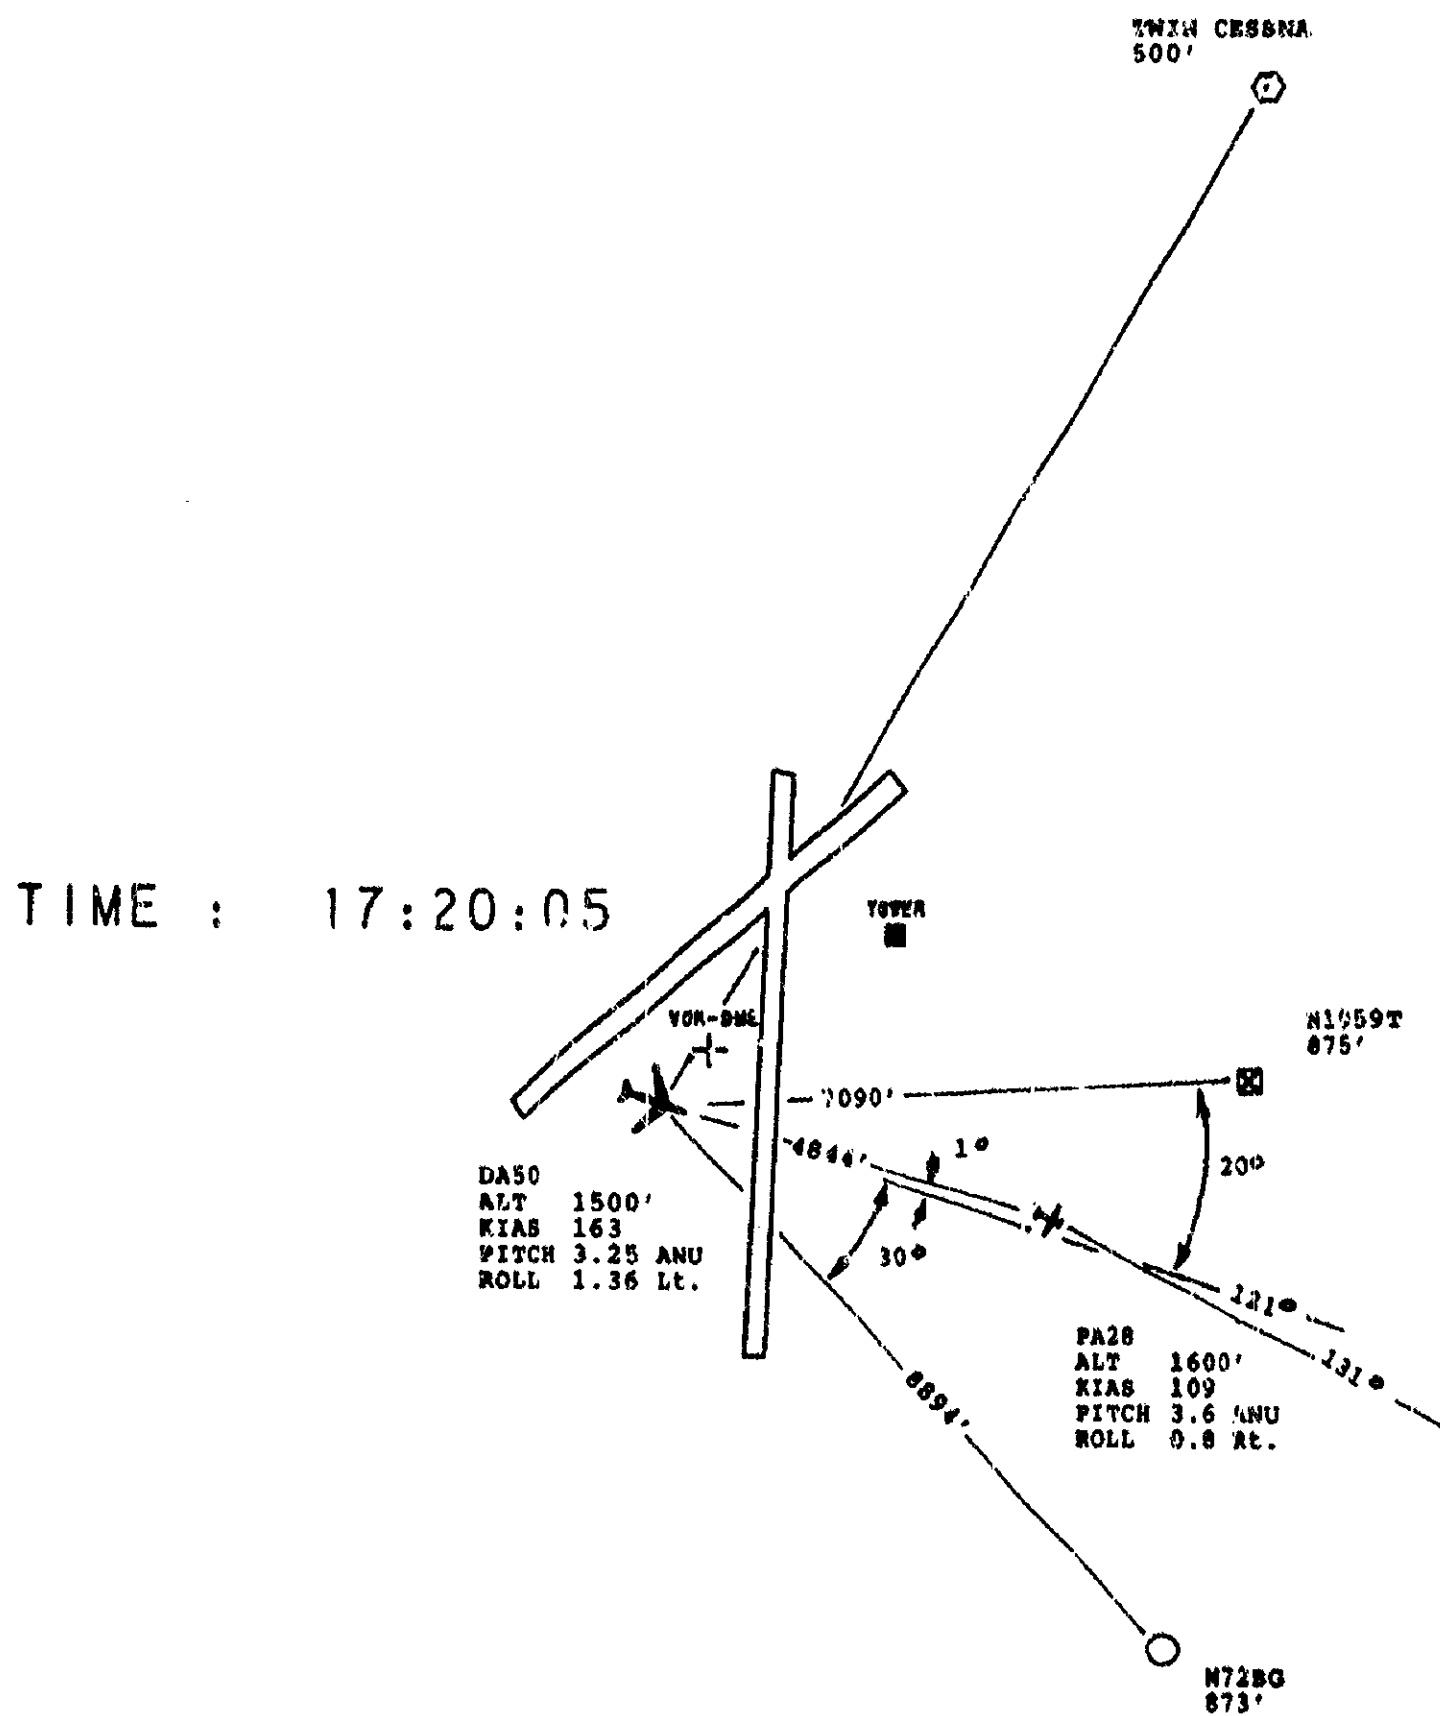
Figure 3.—Radar positions of aircraft at 1720:05.

you're overhead the field, sir?" The captain said, "Yes, sir." At 1720:05, the controller then said, "Okay, plan number three following traffic turning downwind abeam the tower, additional traffic is at your one o'clock westbound at one point five." At this time the DA50 was about wings level on a heading of 121° at about 163 knots indicated airspeed (KIAS). The captain stated, "We're lookin' eight four bravo." (See figure 3.) At 1720:14, the DA50's speed had been reduced to 151 KIAS when a right turn was started. Immediately, the controller stated, "Okay, sir, you're closing on him. He's, uh, light aircraft at, uh, your one to twelve o'clock, westbound." (See figure 4.) At the same time the controller was giving the crew the additional traffic, the first officer called to the captain, "Flaps twenty. Gear down before landing checklist," and then the captain said, "You're eat'em up." This comment was immediately followed by the sound of the landing gear warning horn at 1720:19. At the same time the DA50 established a 5° right bank and maintained it for 41 seconds while the speed was decreasing.

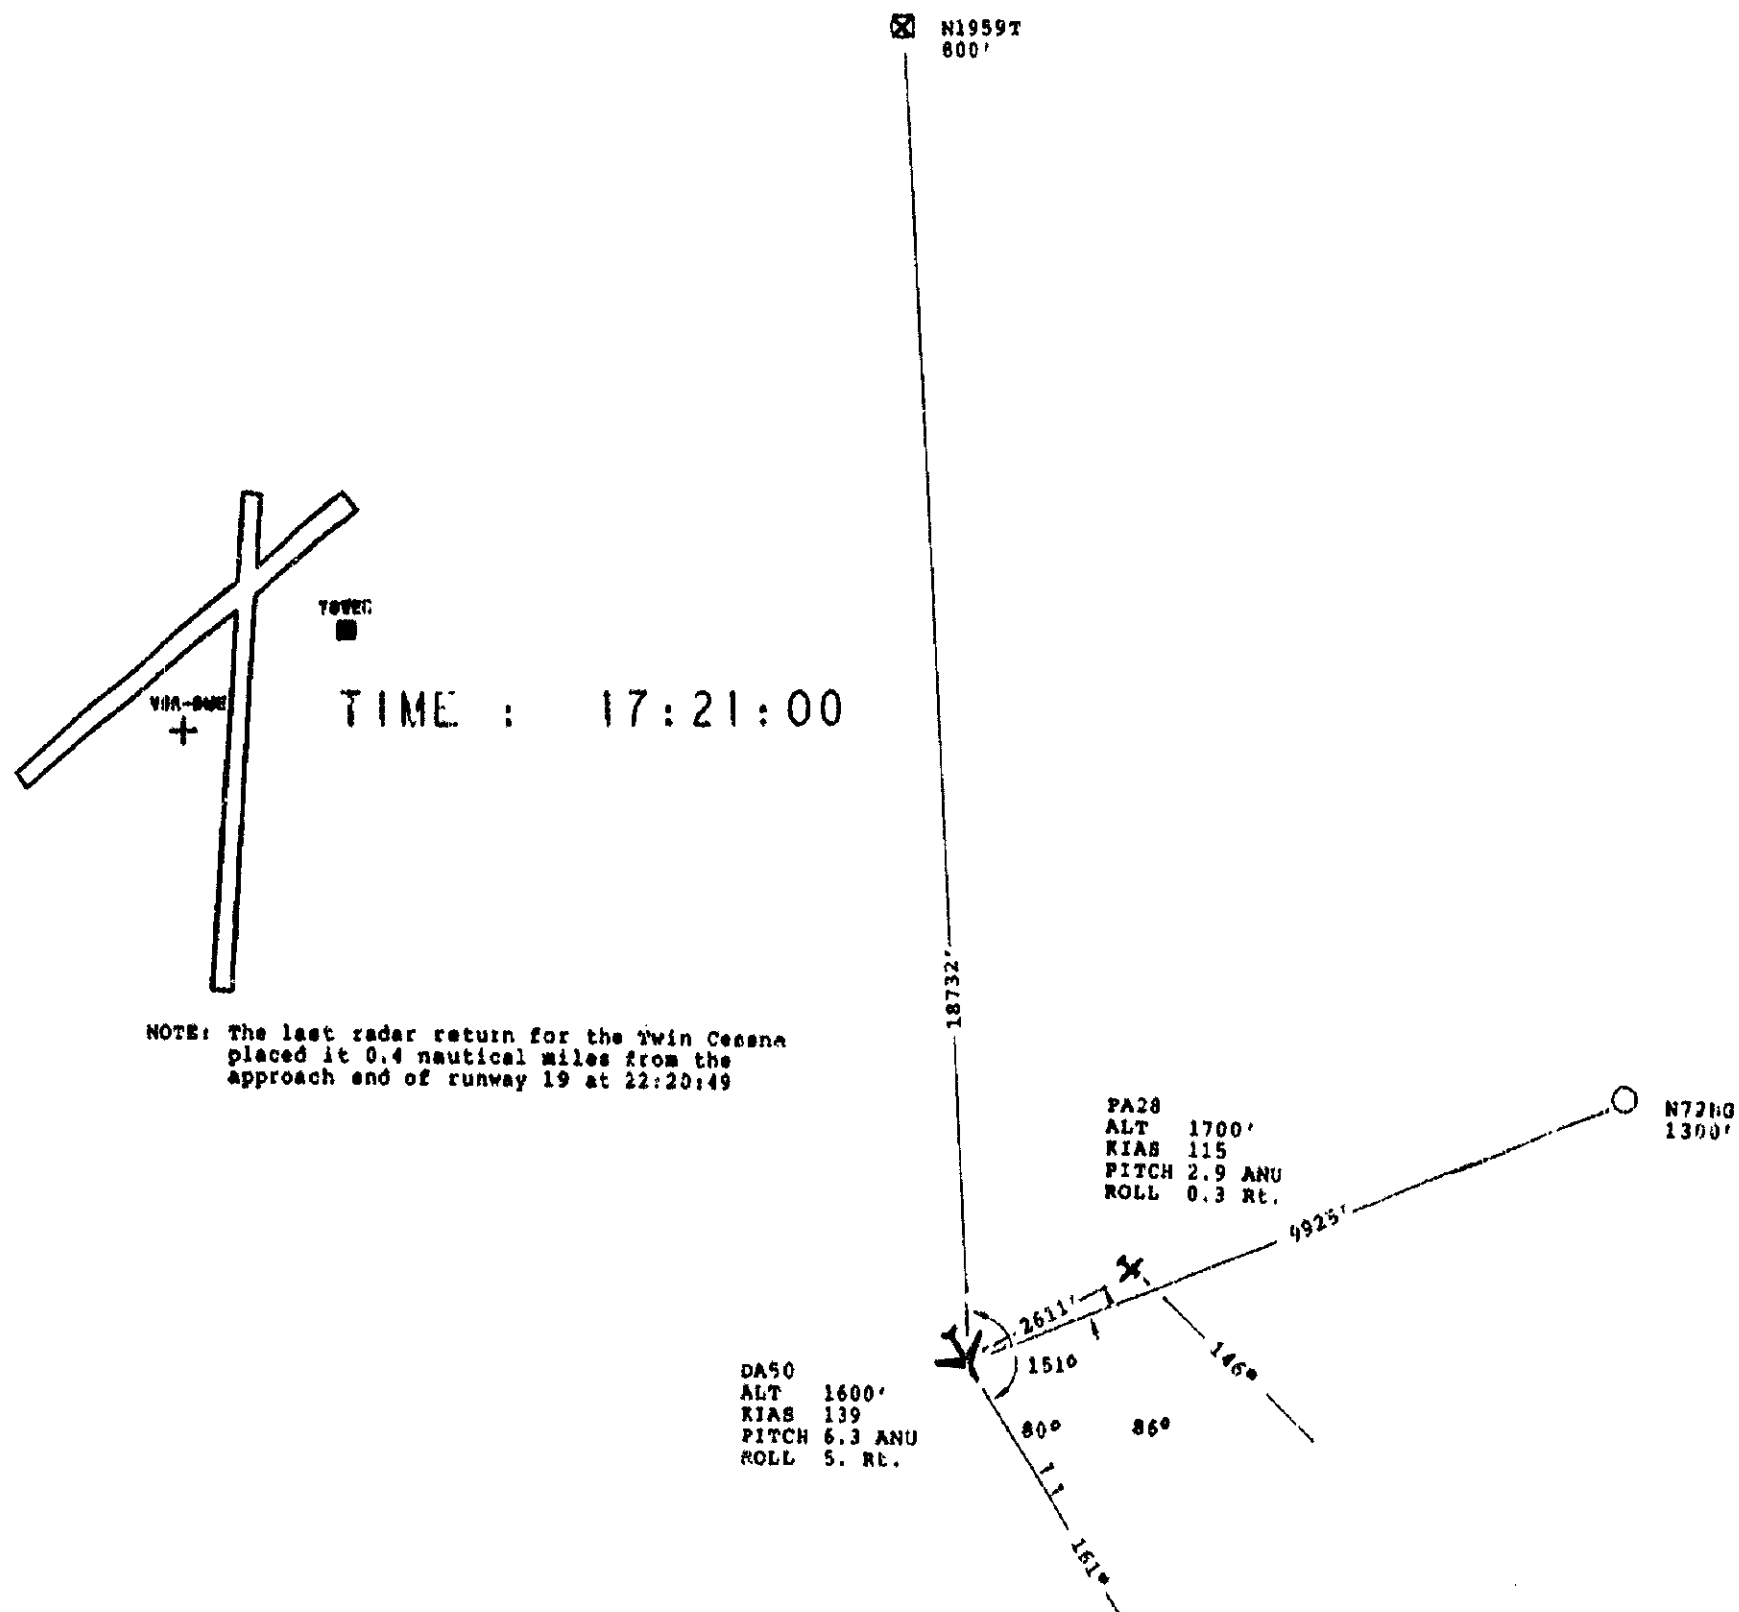
Figure 7.—Radar positions of aircraft at 1721:00.

The controller then turned his attention to the other traffic. At 1720:50, the CVR picked up the sound of a whistle in the cockpit, followed 10 seconds later by the first officer stating, "What kind of Cessna is that?" and the captain replied, "I don't know, I'll ask him." At this point the DA50 is almost wings level, rolling out of the slight right turn. (See figures 7 and 8.) However, there were five other immediate transmissions over the frequency between the controller and three other airplanes, one of which was N1959T which was cleared to make a short approach and land. N1959T acknowledged at 1721:19. The following are the final events recorded by the CVR up until the time of the collision.

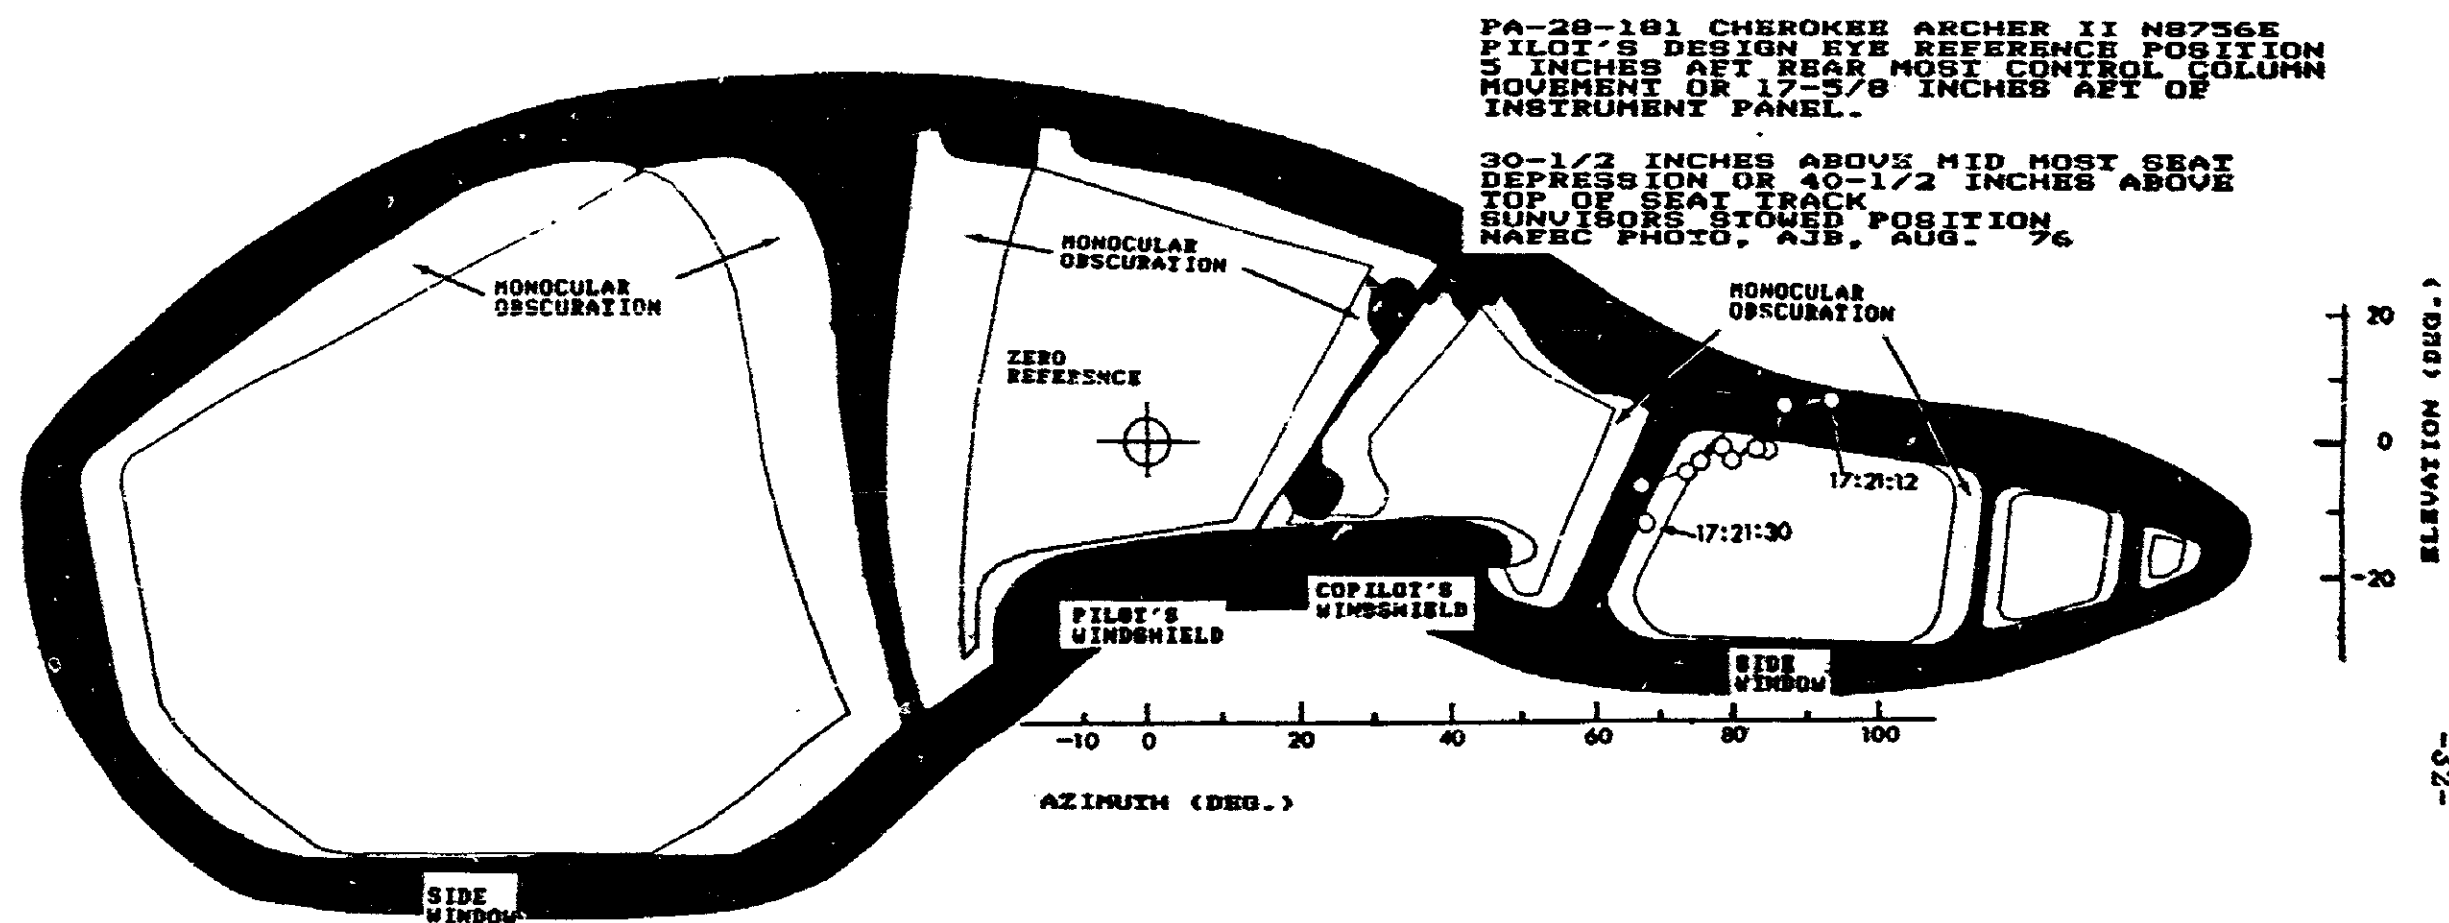
Figure 15.—Cockpit visibility study for the PA28 pilot.

About 30 seconds before the collision, the DA50 was positioned about 109° to the right and about 1° below the DER for the PA28 pilot. Eight seconds before the collision, the DA50 was about 77° to the right and 1/2° below the DER.

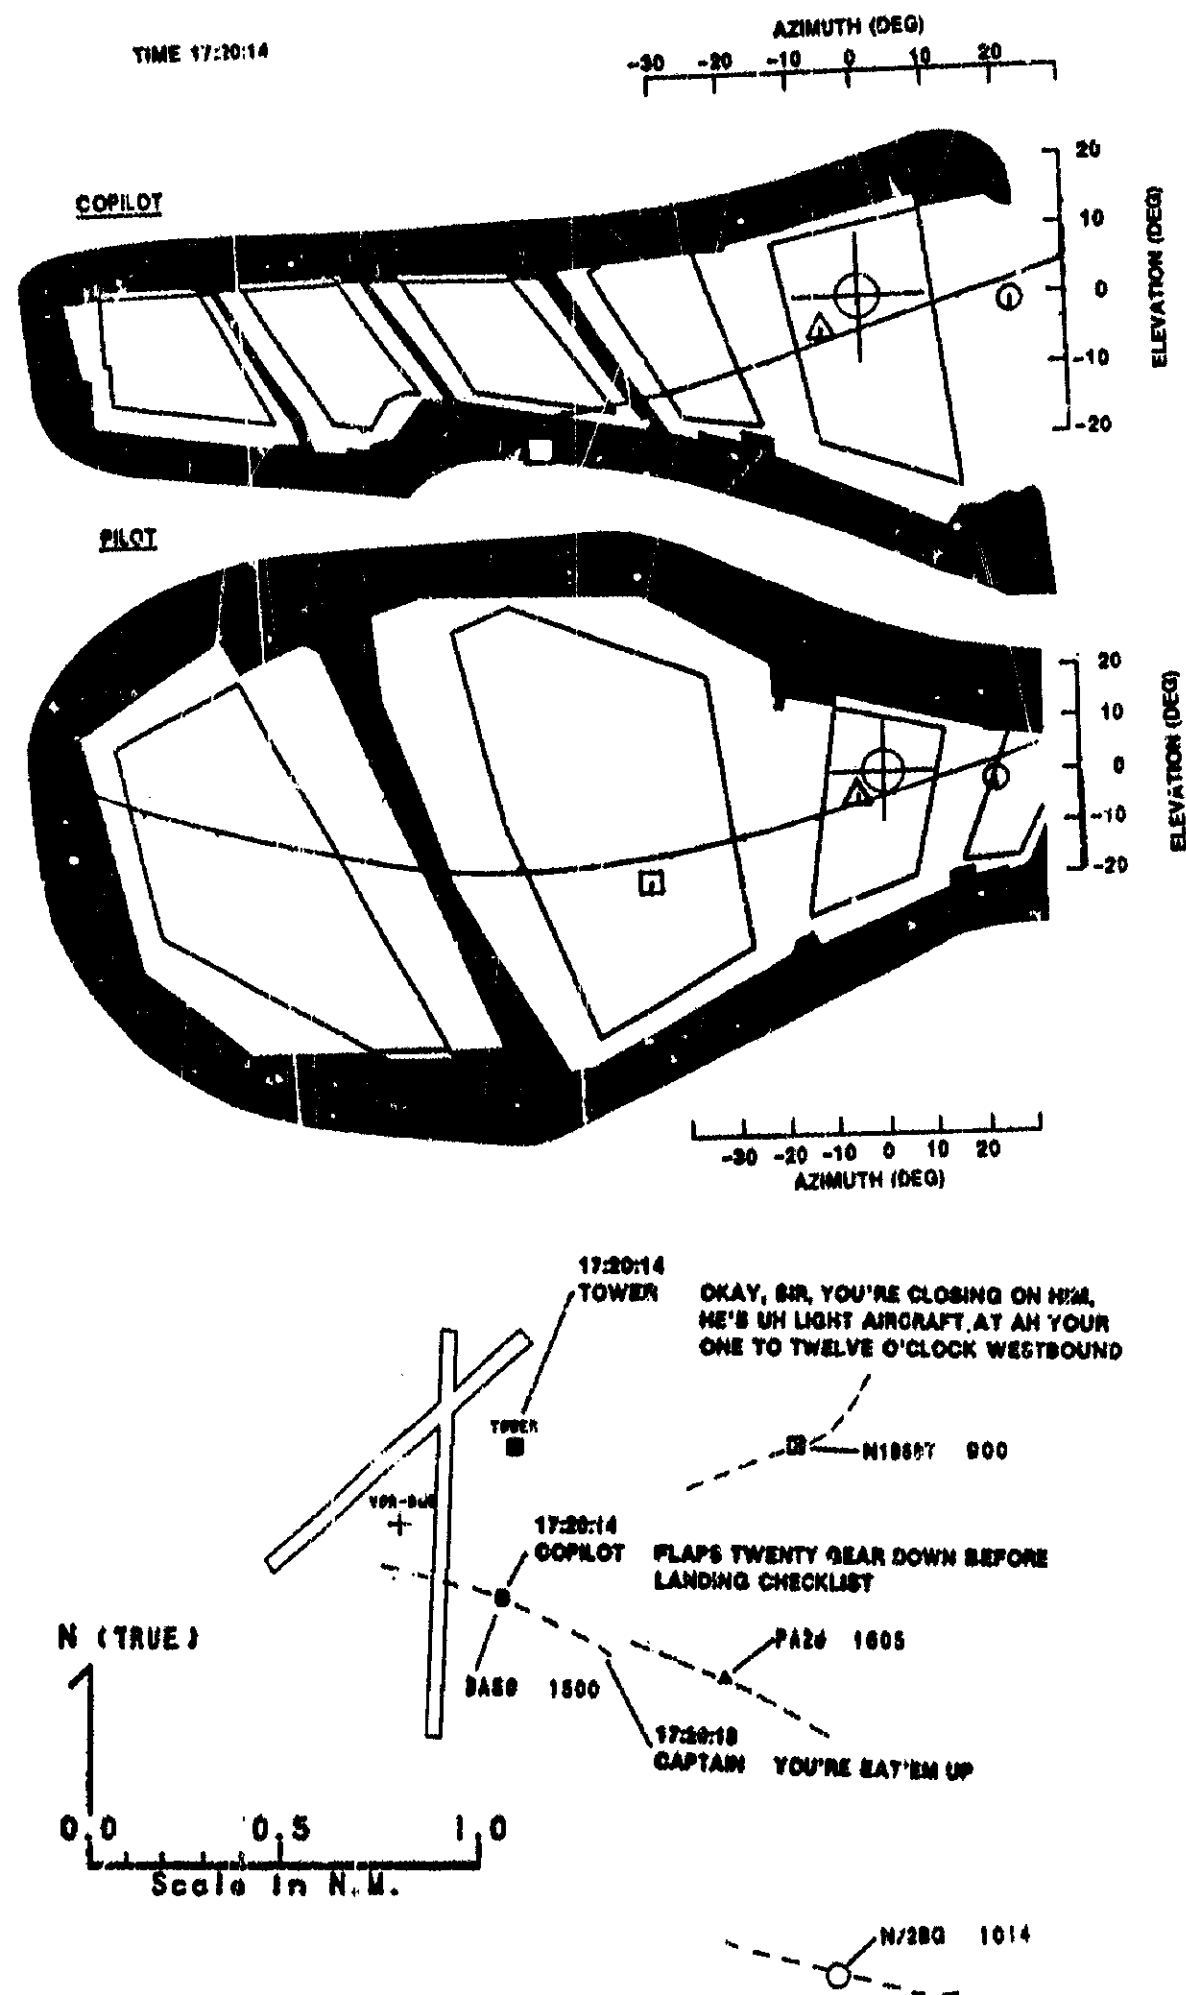
Figure 19.—Composite radar positions and cockpit visibility plot of aircraft at 1720:14.

Because the local controller was not aware of the DA50, he was surprised when the captain reported over the airport, but he managed to identify the DA50, sequence it with the other landing traffic, and issue traffic advisories. He sequenced the DA50 to be number three behind N1959T and correctly described N1959T's location as turning downwind abeam the tower. However, the local controller did not provide the proper description for N1959T, a Twin Bonanza, to the flightcrew. Furthermore, the controller erroneously reported the PA28 traffic as "westbound" in two instances 9 seconds apart -- at 1720:05 and at 1720:14 and did not say that it was an overflight. (See figure 19.) At this time, N1959T was in view at about the 10 o'clock position slightly below the horizon about 1.2 miles away. The PA28 was in view just under a mile directly ahead. N72BG was about 30° to the right of the captain's viewing angle about 1.7 miles ahead and moving closer to a 1 o'clock position than the PA28. Actually, both N1959T and N72BG were turning to the downwind direction at this time. Also, at 1720:14, the DA50 made about a 15° right bank.

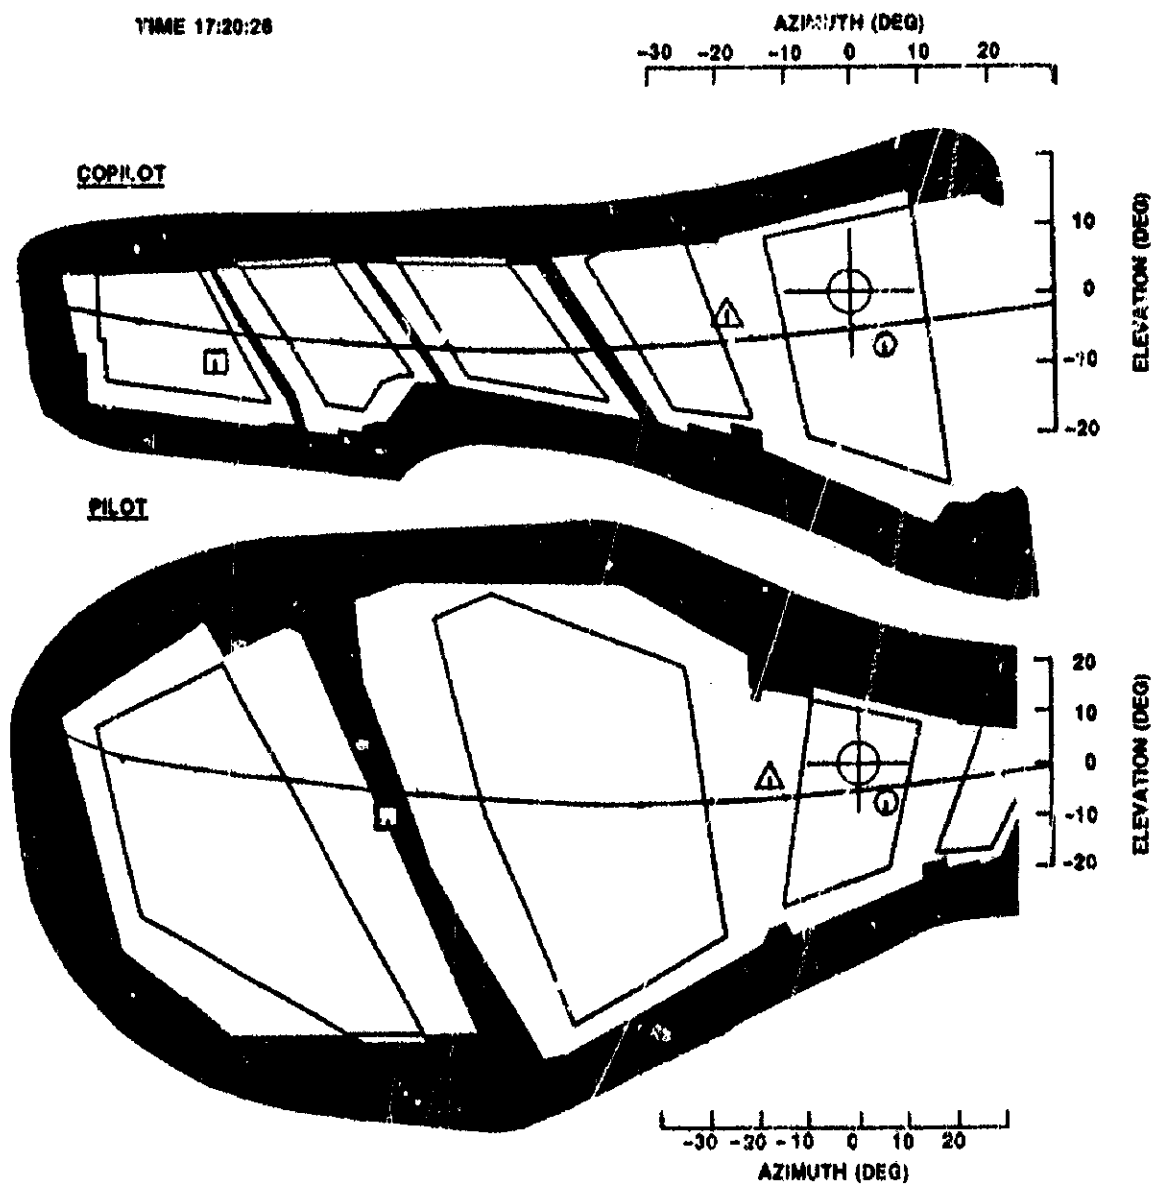
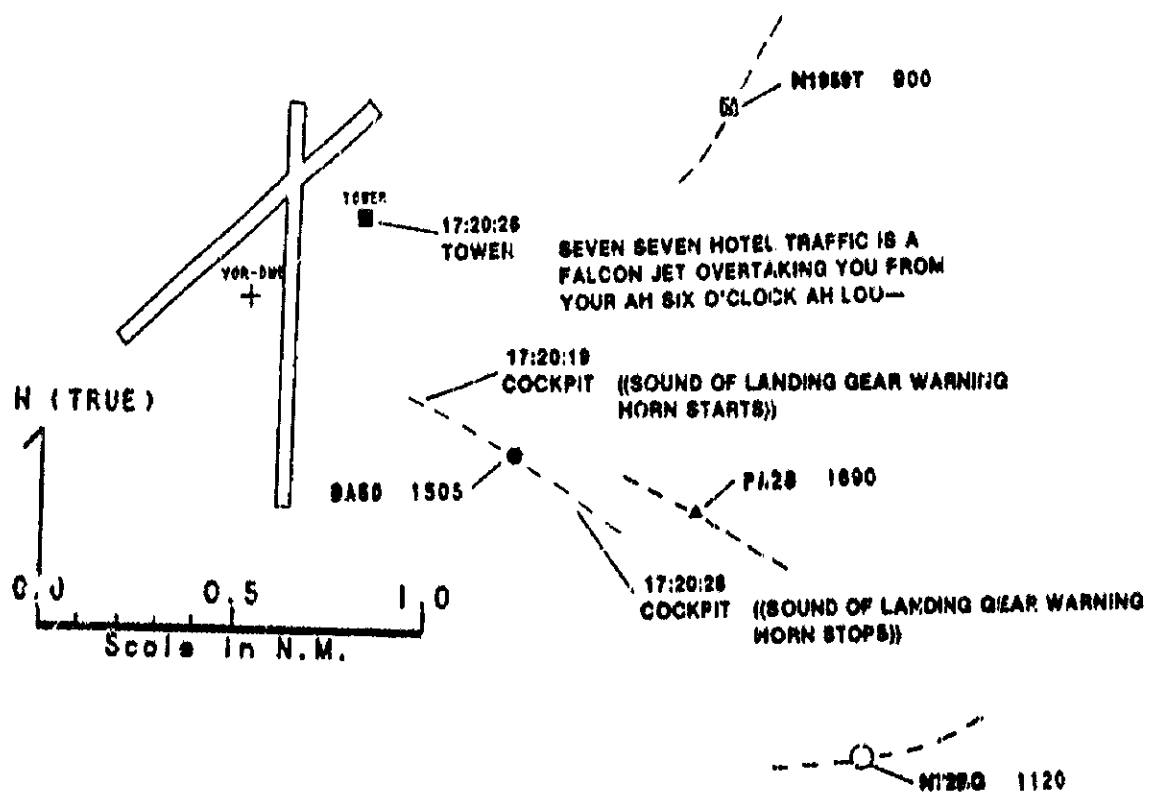
Figure 20.—Cockpit radar positions and cockpit visibility plot of aircraft at 1720:26.

At 1720:26, when the local controller advised the pilot of the PA28 about the DA50 at his 6 o'clock position, all three airplanes were in view of the DA50 flightcrew. (See figure 20.) At 1720:41, when the local controller asked the DA50 flightcrew if they saw the traffic, N1959T was in view about 124° to their left almost 4 miles away traveling northbound on the downwind leg of the traffic pattern, the PA28 and N72BG appeared close together and in view about 40° to the left of their DER points. The PA28 was about 3/4 mile ahead just above the horizon and N72BG was slightly below the horizon about 1.3 miles away, and to the right of the PA28. (See figure 21.) About this time, when the captain acknowledged sighting what is believed he thought to be the "westbound" traffic, all three airplanes were in his view, and only N1959T was far to the left, out of the first officer's view. Twenty seconds later, both the PA28 and N72BG maintained their approximate positions relative to one another and moved to the left horizontally about 46°. N1959T moved horizontally to the left and out of the first officer's view. (See figure 22.)

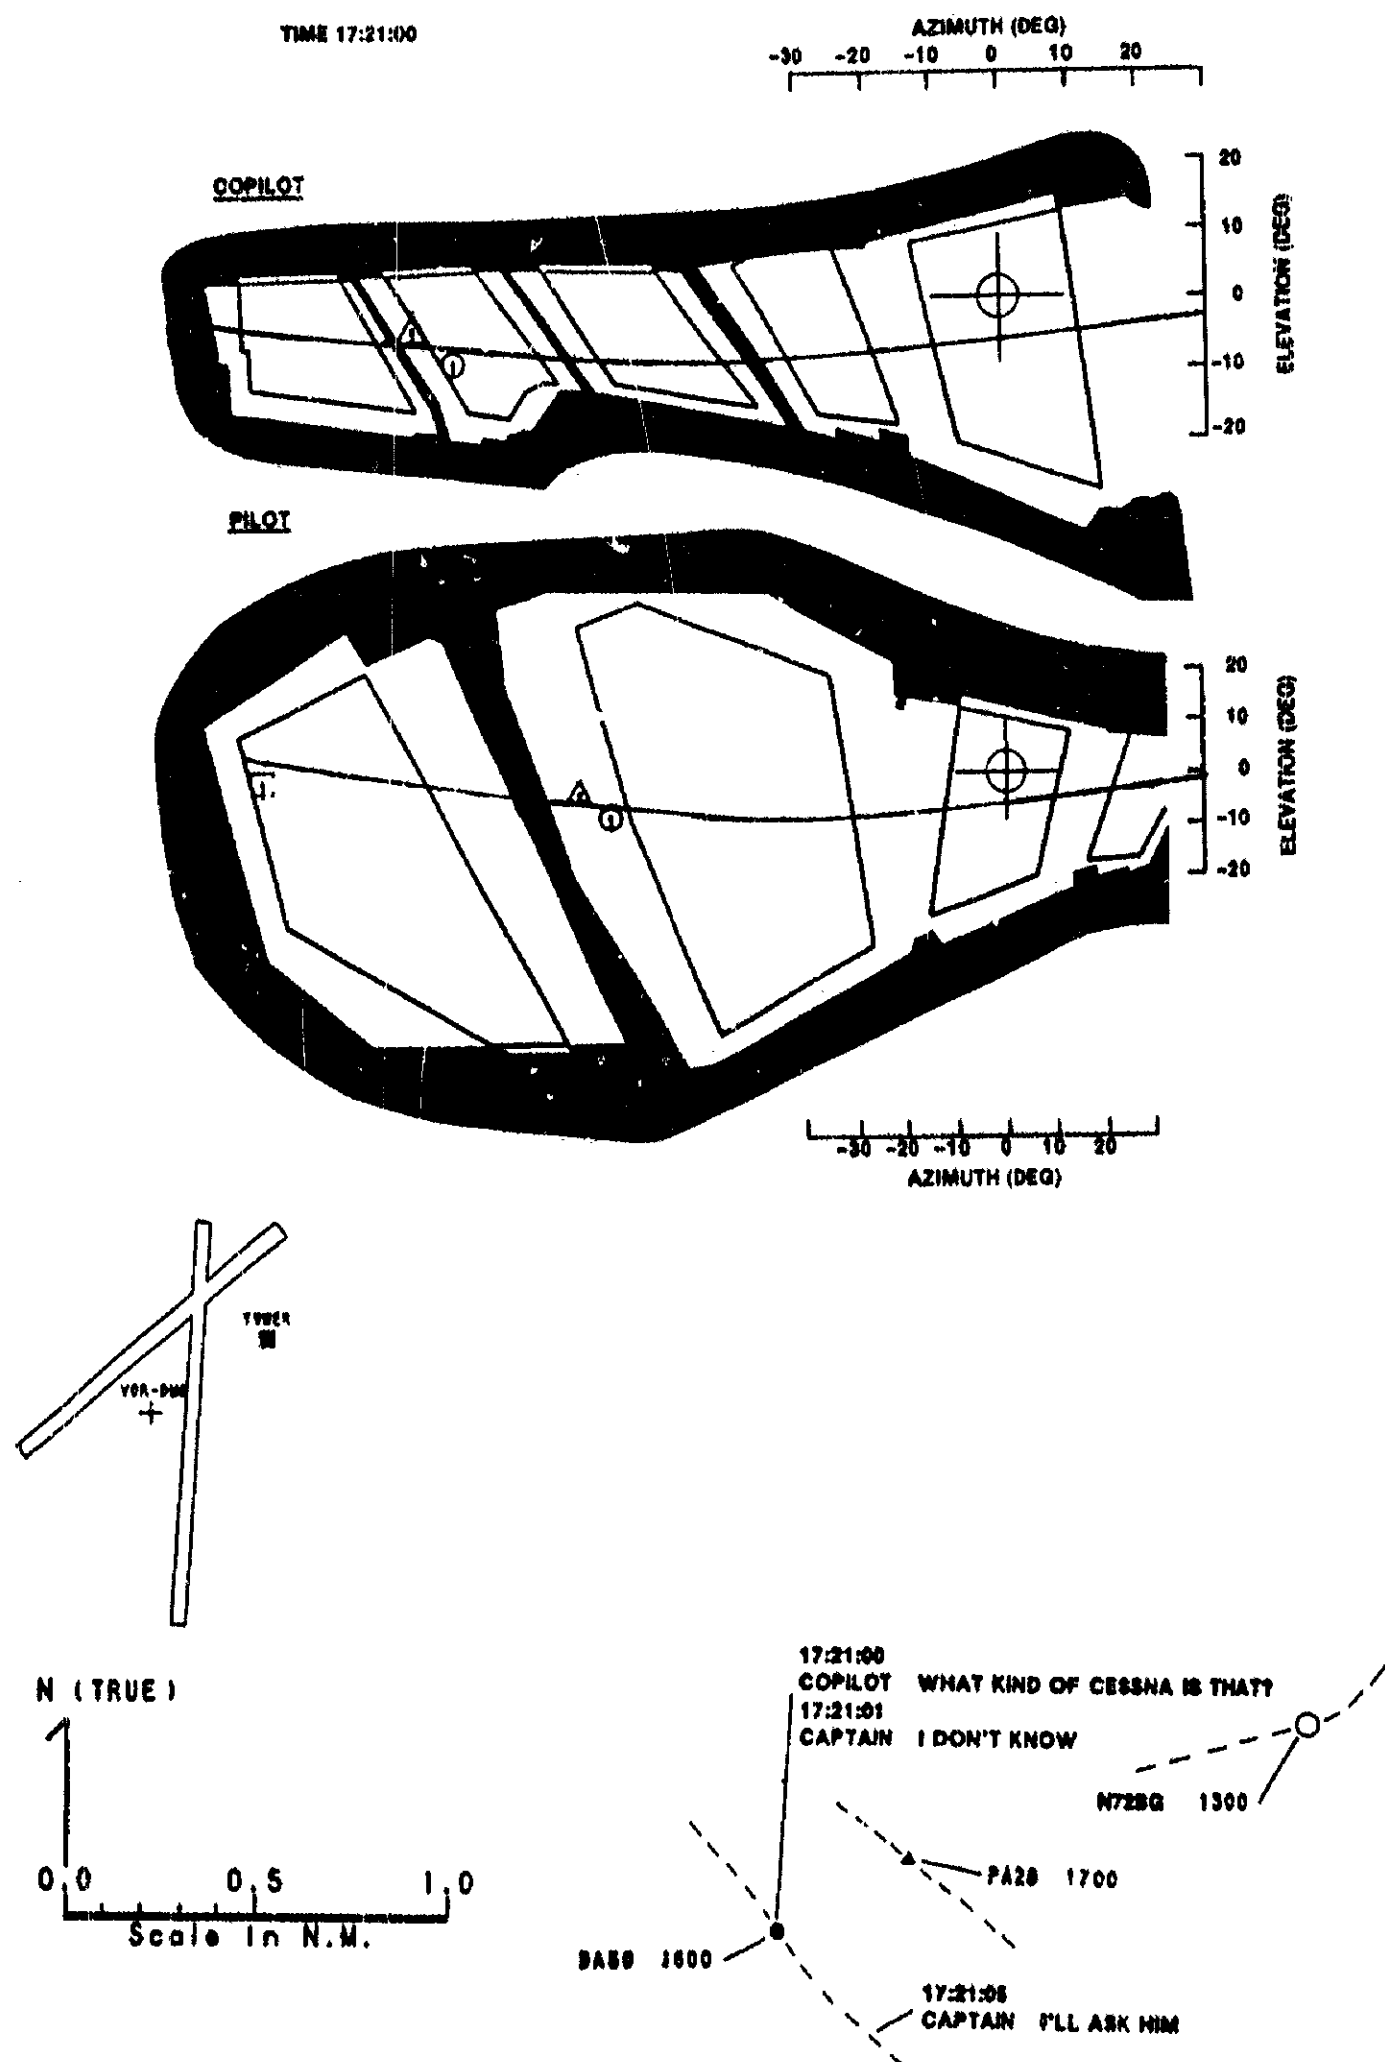
Figure 22.—Cockpit radar positions and cockpit visibility plot of aircraft at 1721:00.

At 1721:00, when the first officer asked "What kind of Cessna is that?" the PA28 and N72BG remained in view in about their same relative positions about 80° to the left of the crew's DER, but the PA28 was about 1/2 mile away and N72BG was about 1.6 miles away. Eight seconds before the collision when the captain said, "Hey, watch out, this guy's comin' right at us," the DA50 was in about a 30° left bank and the PA28 and N72BG were about 63° to the left and about 20° above the DER for the captain. They were not in the first officer's view. The PA28 was just above the horizon and N72BG was directly below the PA28 which was about 1/3 mile away or about 2,006 feet from the DA50. N1959T was out of the view of both pilots. (See figure 23.)
